# PRE- SHIPMENT INSPECTION SURVEY REPORT

## CONTAINER # SZLU 927995-9 REEFER · 40 feet (1xRF40/FF)

REQUISITION Nº 180226-1

According to the request of our client, IAMSAClass GROUP INC. on behalf of NAME OF OUR PRINCIPAL, carried out a Pre- Shipment Inspection and Loading Supervision of the CONTAINER # SZLU 927995-9 REFFER of 40 feet loaded with boxes of frozen beef tails and fat; the process was performed at FRIODOCK Deposit and Dock # 6 at Buenos Aires, Argentina.

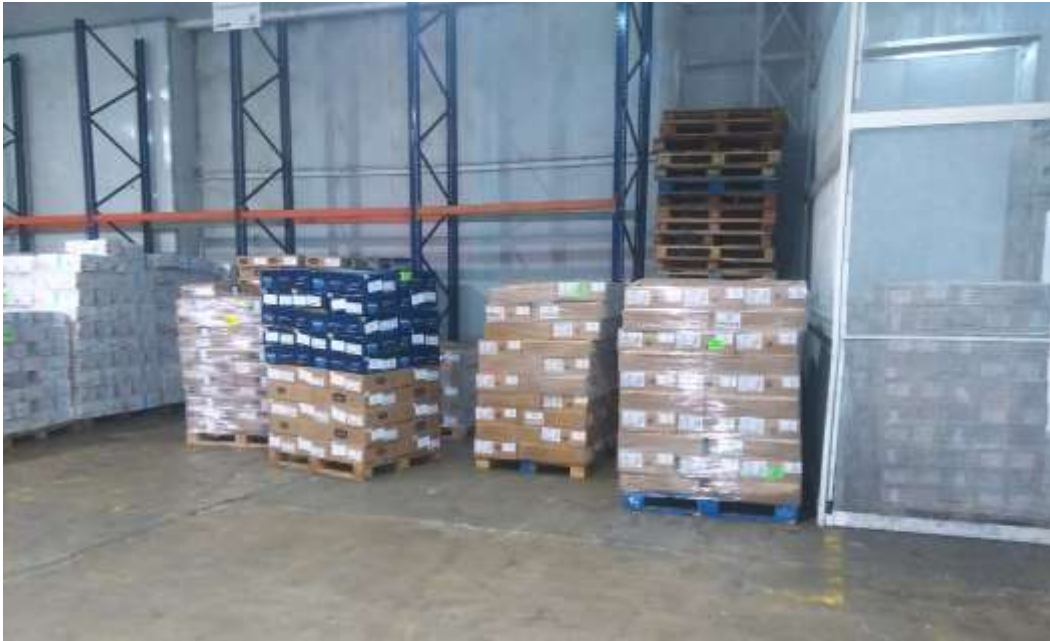
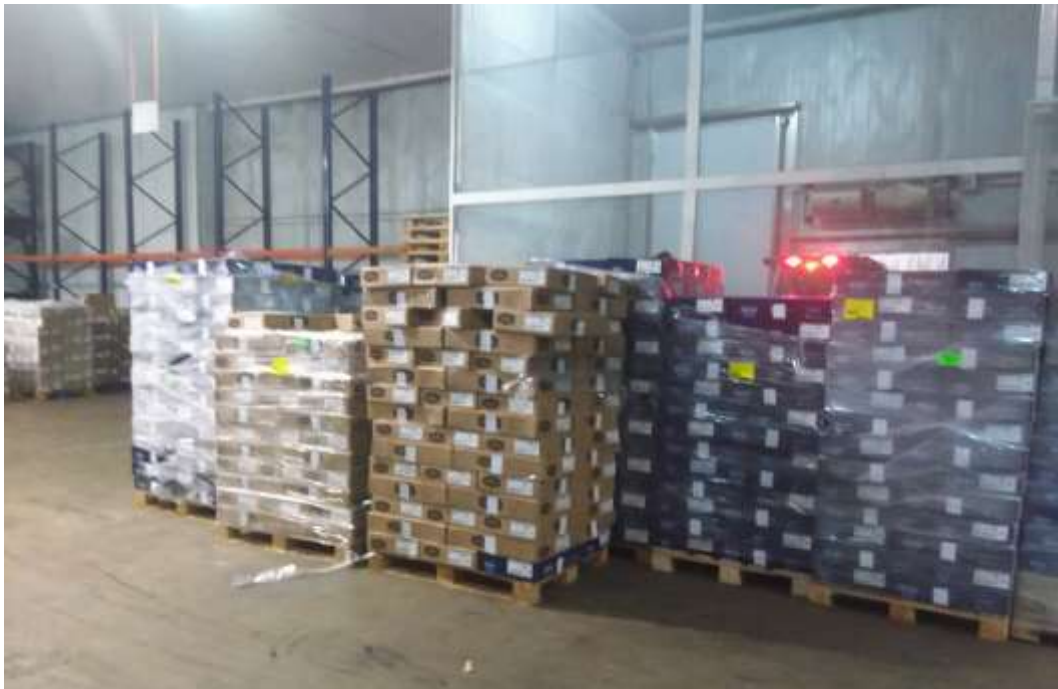
**Inspection of the pallets containing Tails boxes in good order**

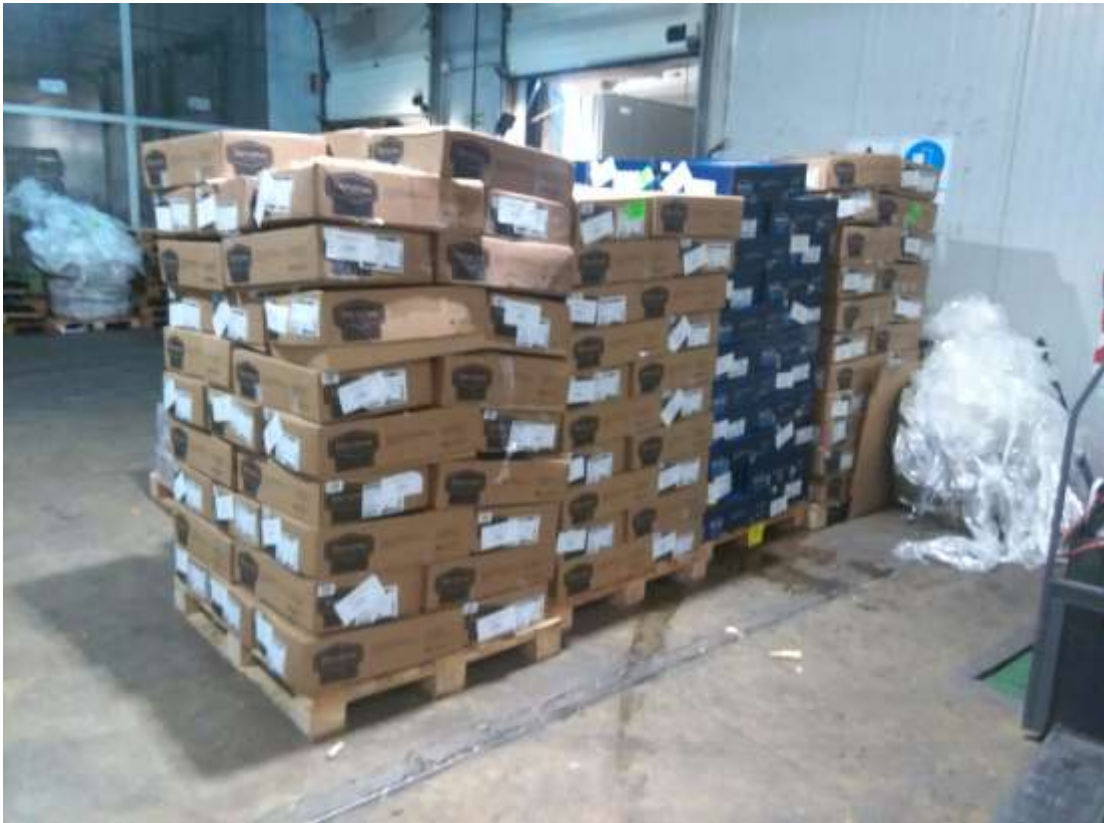
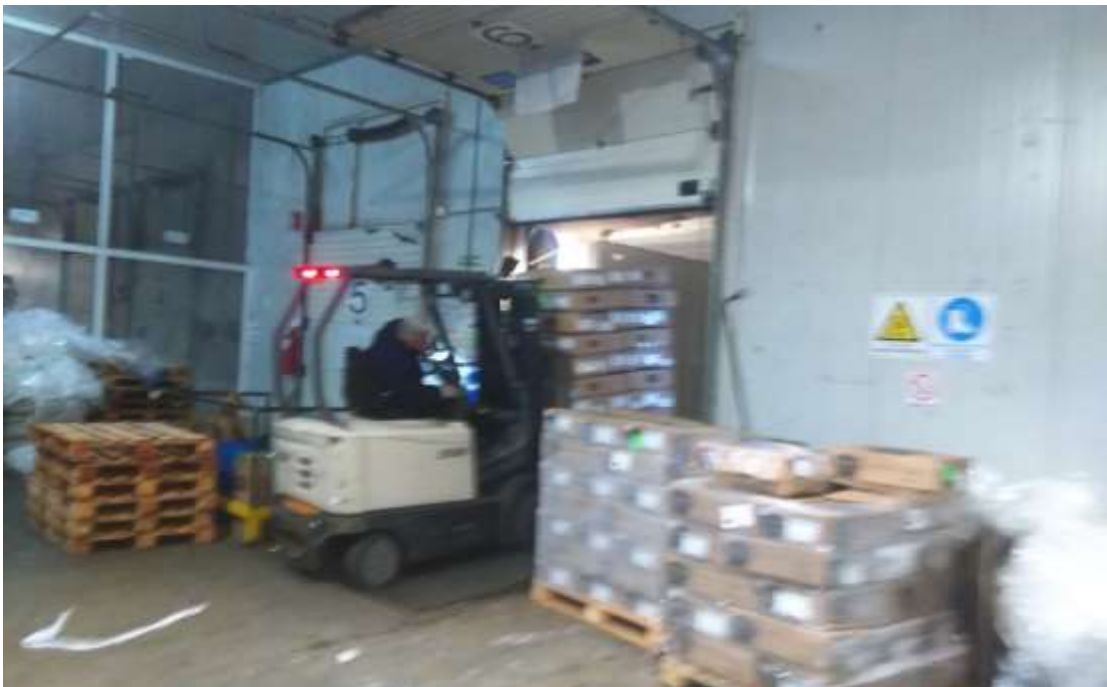
**Inspection of the pallets containing Fat boxes in good order**

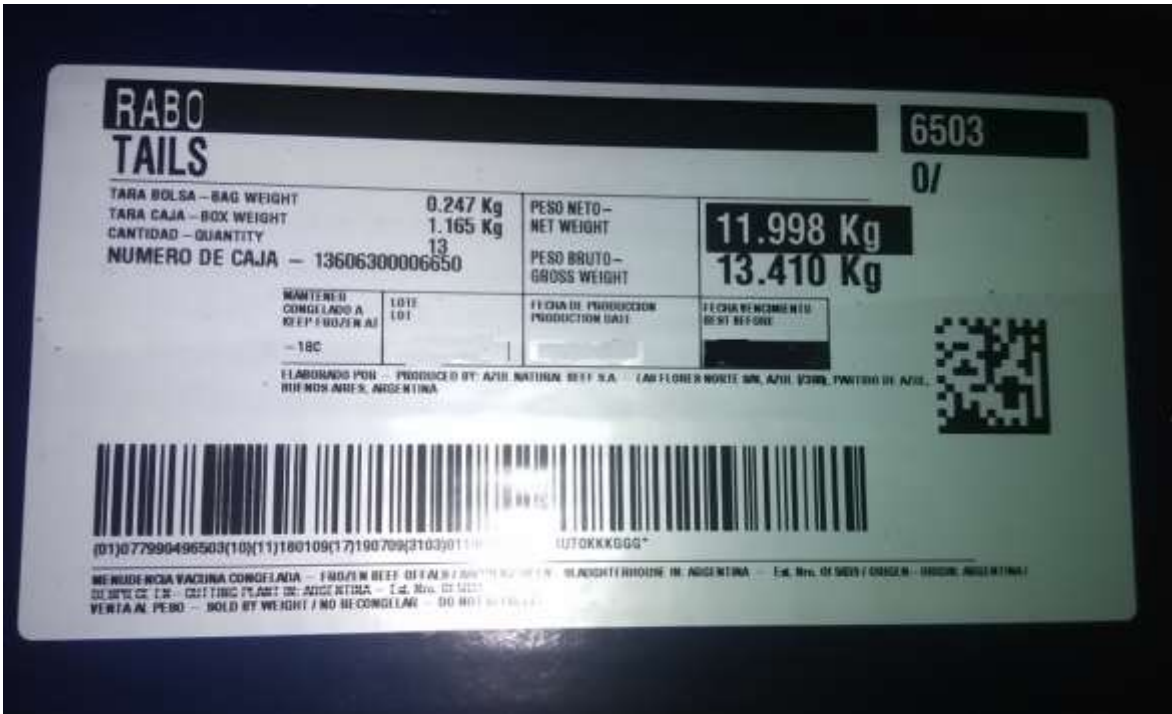
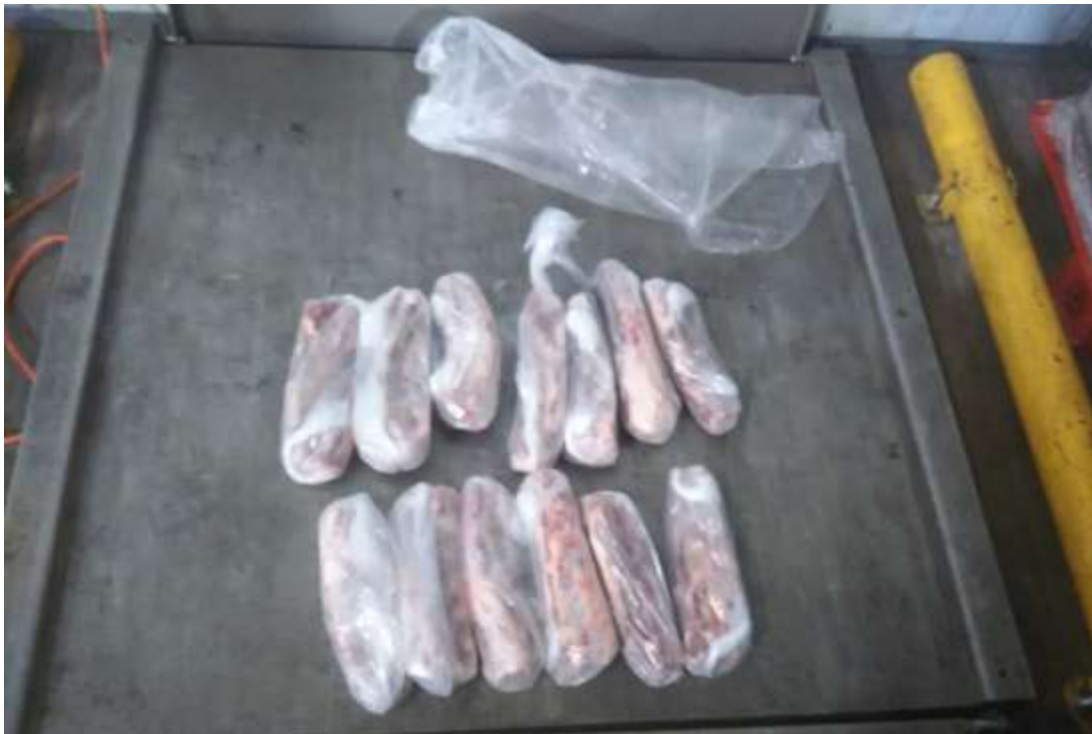
Photo from label of Tail Box and packaging and from open cardbox as well

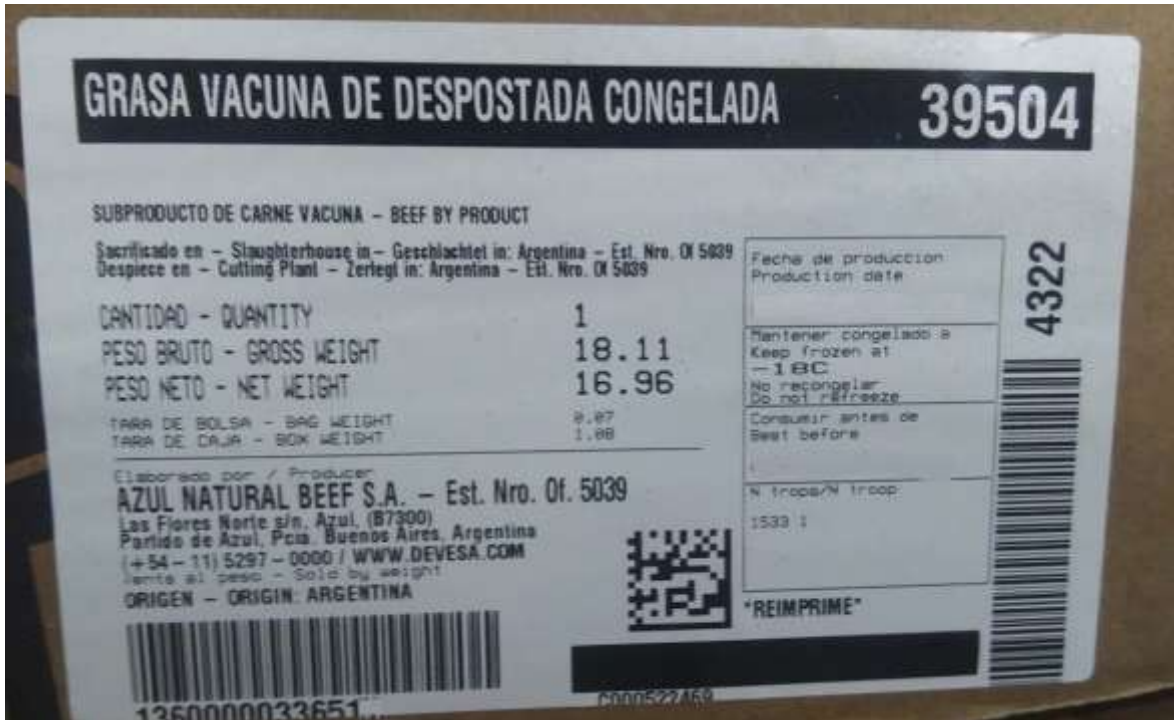
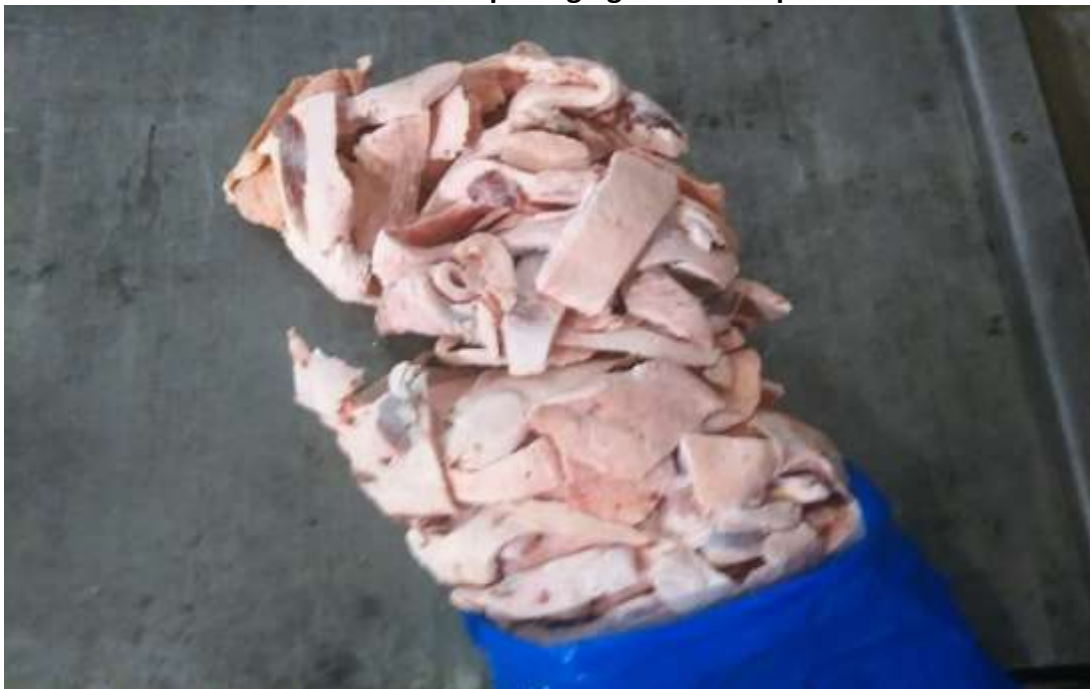
Photo from label of fat Box and packaging and from open cardbox as well

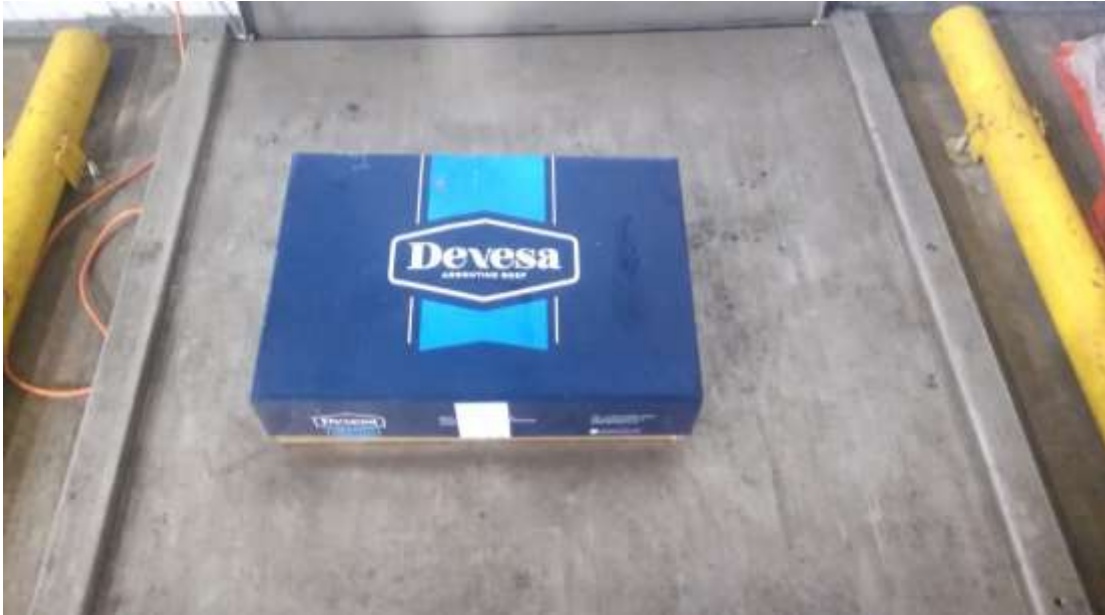
**Check gross weight of these 25 boxes of tails and fat and check net weight & temperatures**

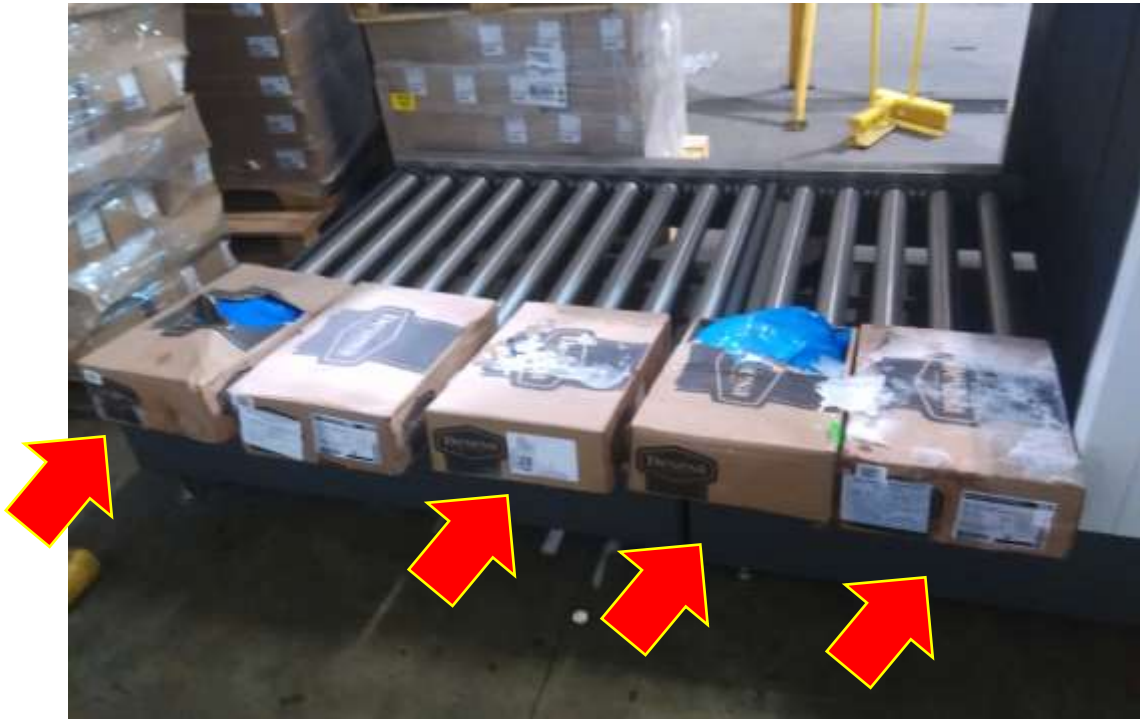
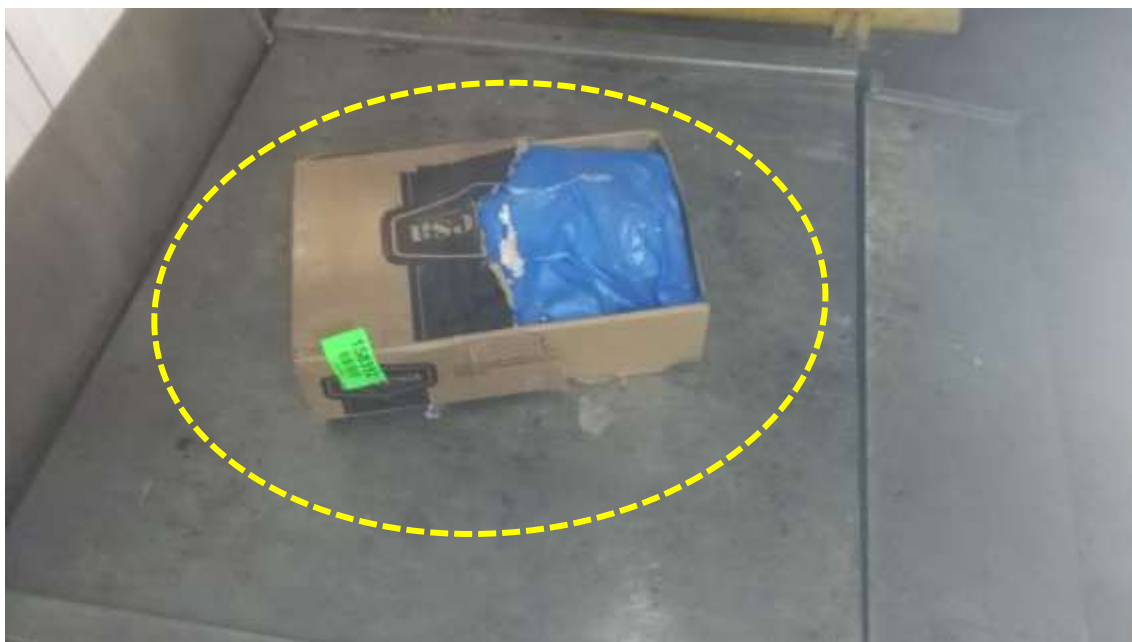
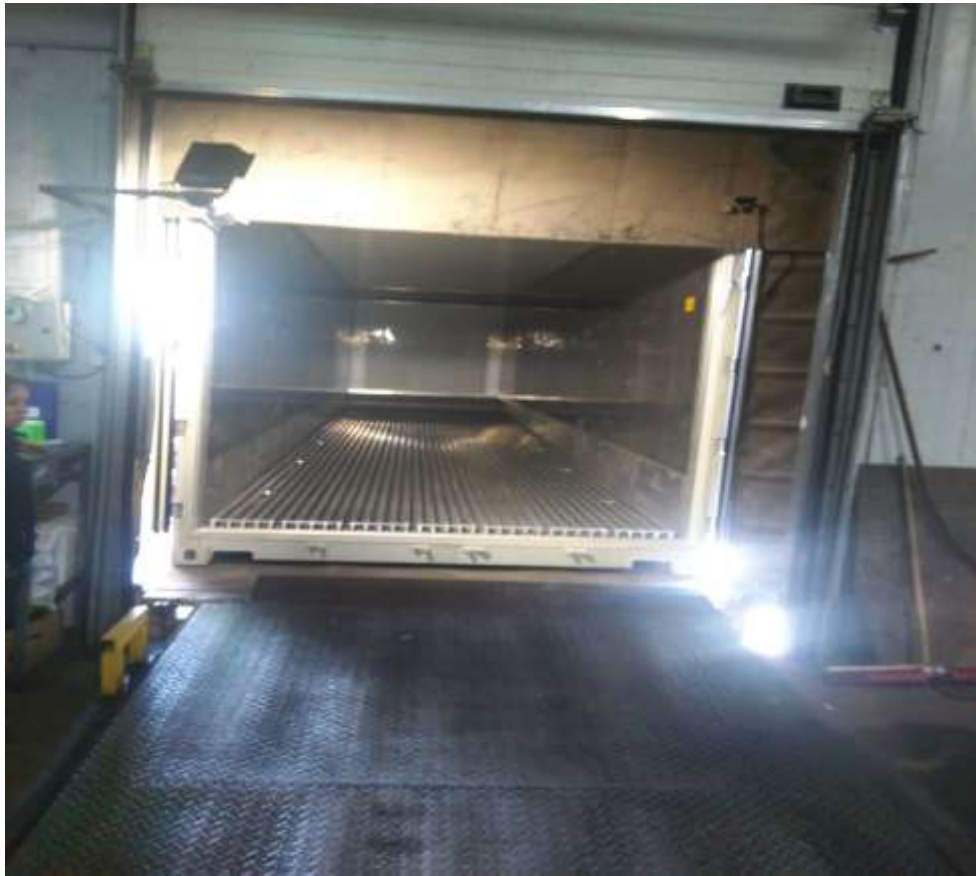
**Container Inspection and Loading Supervision**

3. - The stevedores worked in an acceptable manner overall.
4. - Based upon the cargo conditions loaded without any damage, the undersigned surveyor believes that not the cargos were loaded in an apparently proper manner because they could not load the 38 missing boxes making the last row is not complete and during their transfer and navigation the boxes can fall by the continuous movements that the container undergoes until its destination.
